## TEST REPORT

No. : GZIN2304000067CM01\_EN

Sample Name : Car luggage rack lock cylinder  
 Product Specification : 9340  
 Manufacturer : Xuzhou Fornd Industrial Technology Co., Ltd.  
 Material : Zinc Alloy

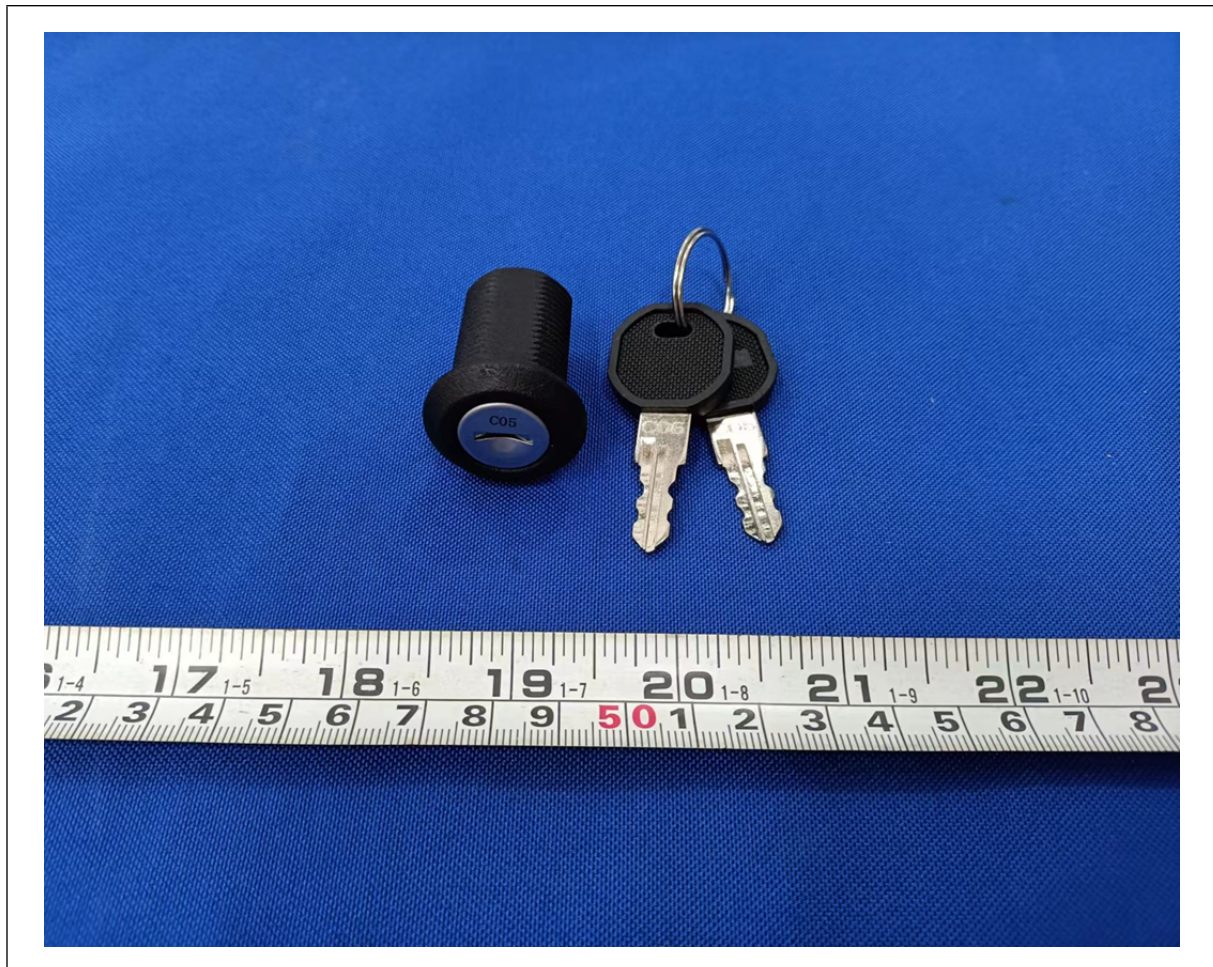
Original Sample Photo:

Name: Car luggage rack lock cylinder

Model: 9340

Clause	Test items	Test requirement	Test method and test condition	Test result	Verdict
/	Durability	After 100 000 cycles test, function normally	Insert the key, and rotate it to 180°, then rotate to 0°, at last pull the key out.	After 100 000 cycles test, function normally.	PASS
